**FEDERAL ON-SCENE COORDINATOR'S
REPORT
for
ALIQUIPPA TIN MILL SITE
ALIQUIPPA, BEAVER COUNTY, PENNSYLVANIA
May 27, 2017 to June 30, 2020**

UNITED STATES
ENVIRONMENTAL PROTECTION AGENCY
REGION III
WHEELING, WEST VIRGINIA

**Federal On-Scene Coordinator's Report
Aliquippa Tin Mill Site**

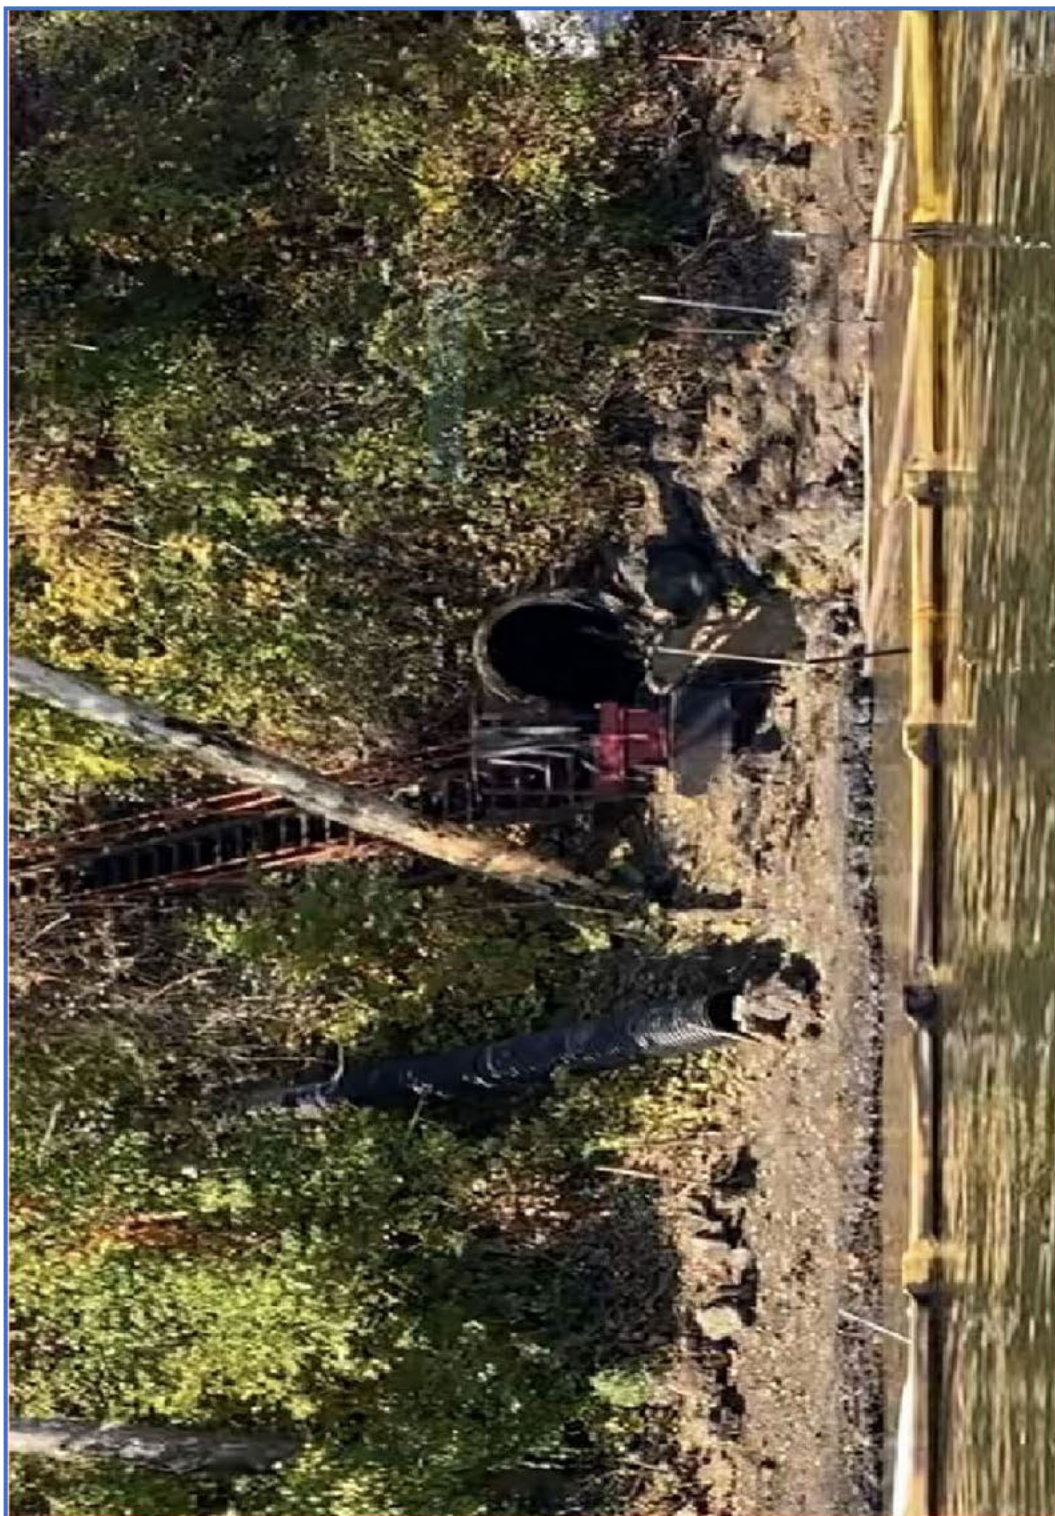
Photolog 184: Condition of outfall and riverbank after Phase 2 response actions – removal of impacted sediments and debris. Picture taken before placement of rip rap. 10/28/19. (START photo outfall zoom.jpg or IMG_0046.jpg)

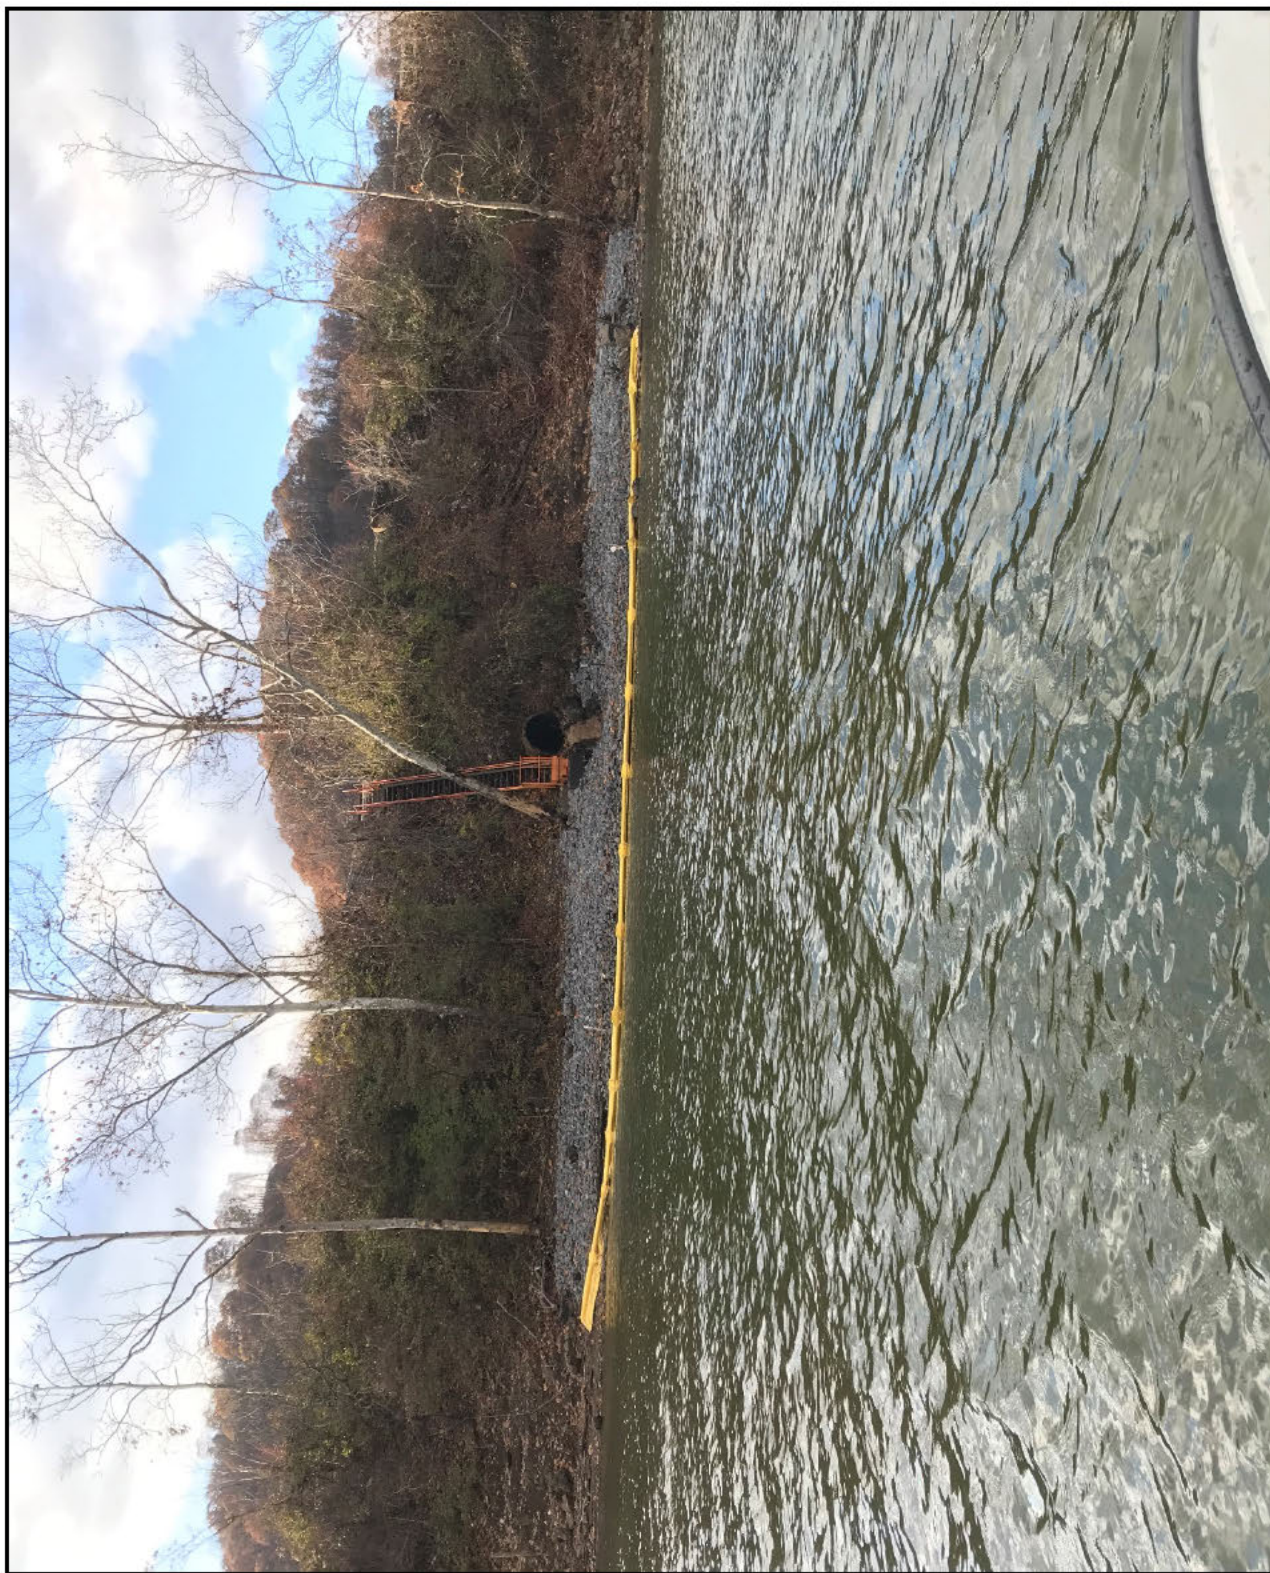
Photolog 185: Final Condition of outfall and riverbank after Phase 2 response actions including placement of riprap. Containment boom remained in place until June 2020. 11/25/19. (START photo IMG_0013.jpg)
